**TESTING / INSPECTION REPORT**

REPORT NO : VT-180511-1

SPECIMEN : TEP1010-BSW series

TEST / INSPECTION ITEMS : Vibration Test

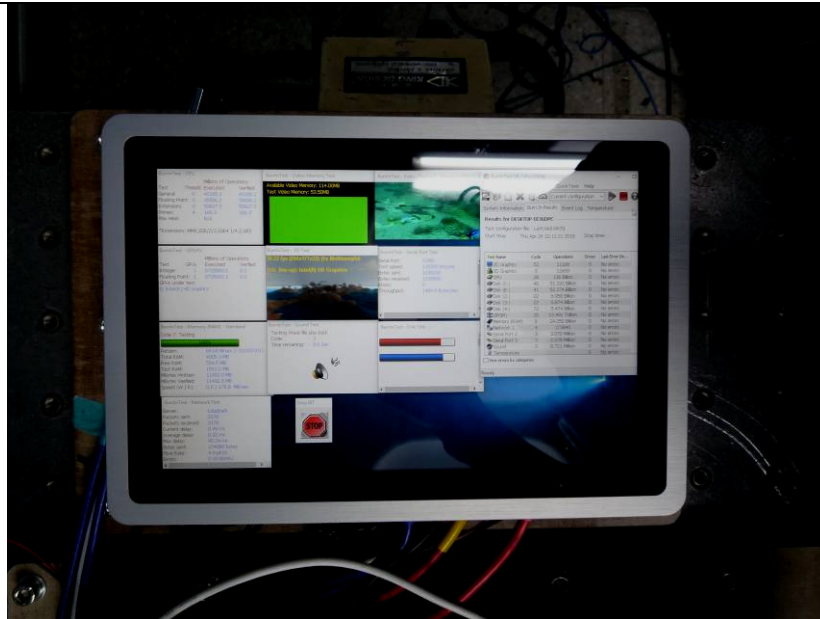
### After test-1

| Describe | PASS | FAIL | Non-Judgment |
|---|---|---|---|
| (2)—No visible damages were found. | | | |
