REPORT NO : DT-180511-2

COMPANY : TechNexion Ltd.  
ADDRESS : 16F-5, No. 736, Zhongzheng Road, ZhongHe District, 23511,  
New Taipei City, Taiwan  
TEL : 886-2-8227-3585  
FAX : 886-2-8227-3590  
SPECIMEN : TEP1560 BSW series  
TEP5-BSW E8000 ---TEP5-BSW E8000  
Power Expansion-LPOE---TXR-P1-12V-POE1  
I/O Expansion-XG21---TXR-I2-GS2-GG8

TEST / INSPECTION ITEMS : Drop Test

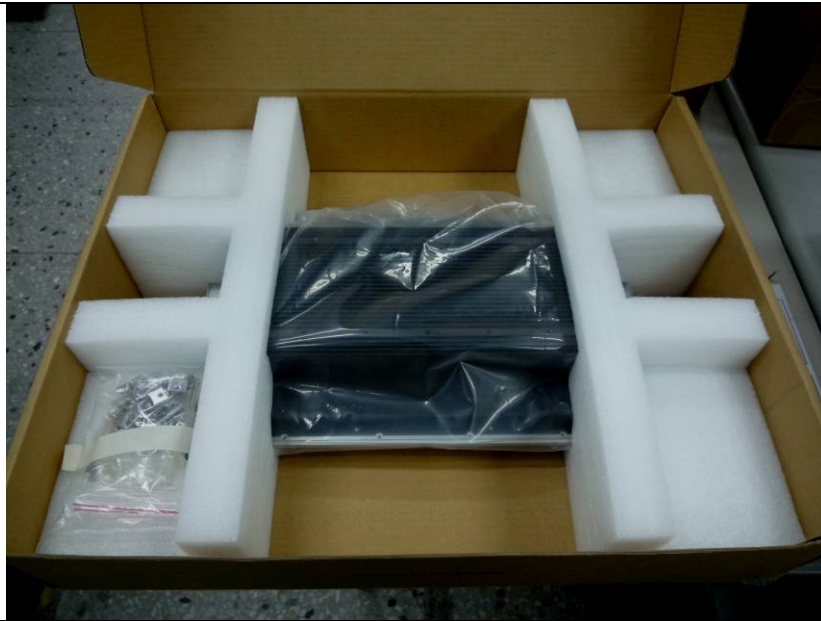
#### After test-1

(1)—Booting function was normal after the test.  
(2)—No visible damages were found.
