VIBRATION LABORATORY<http://www.kdi.tw><http://www.vibration.com.tw>E-mail: service@kdi.tw**TESTING / INSPECTION REPORT**

REPORT NO : VT-180511-2

SPECIMEN : TEP1560 BSW series

TEST / INSPECTION ITEMS : Vibration Test

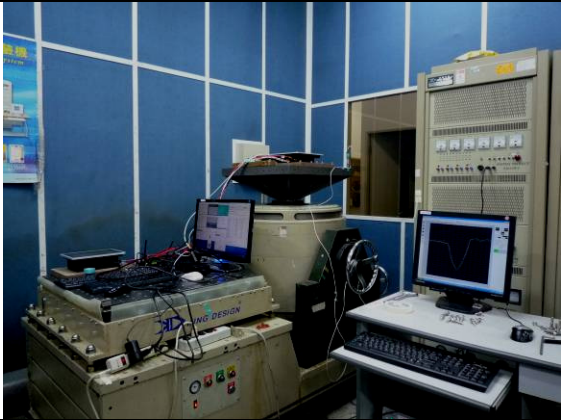
Vibration testing photos	
Testing equipment	Z axis

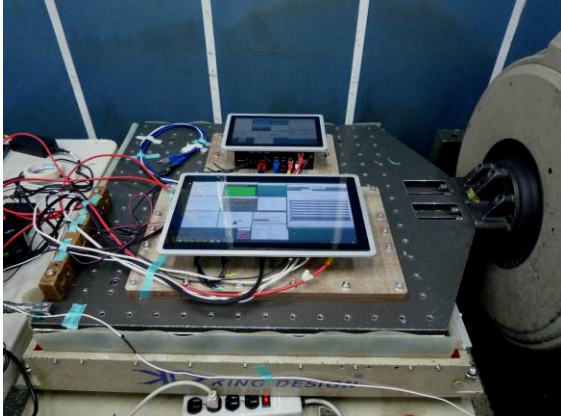
X axis	Y axis

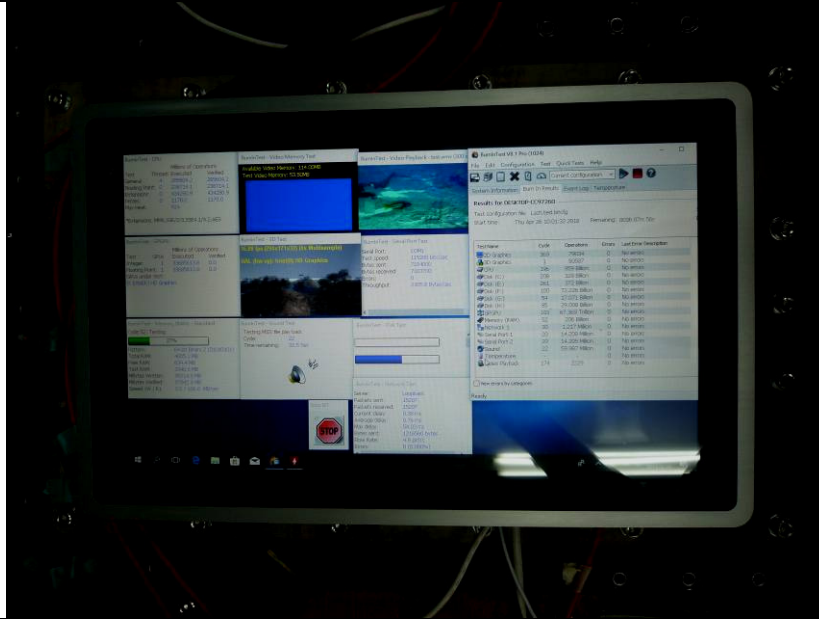
Describe	PASS	FAIL	Non-Judgment
Function judgment ⁽¹⁾	√	---	---
Appearance check ⁽²⁾	√	---	---
(1)—Booting function was normal after the test.			
(2)—No visible damages were found.

KING DESIGN INDUSTRIAL CO., LTD.
4F,NO. 3, Lane 270, Pei Shen Road Sec. 3,
Shen Keng Dist., New Taipei City, 222, Taiwan, R.O.C
TEL: 886-2-2662-5100 FAX: 886-2-2662-3094
VIBRATION LABORATORY
<http://www.kdi.tw>
<http://www.vibration.com.tw>
E-mail:service@kdi.tw
Testing photos
After test-1
