**TESTING / INSPECTION REPORT**

REPORT NO : DT-180712-1R

TEST / INSPECTION ITEMS : Drop Test

Model : TWP1560-BSW series  
TN140\_TEP5-BSW --- TEP5-BSW-N3710  
Power Expansion-L112 --- TXR-P1-12V-LAN1  
I/O Expansion-XS21--- TXR-I2-S2-G8

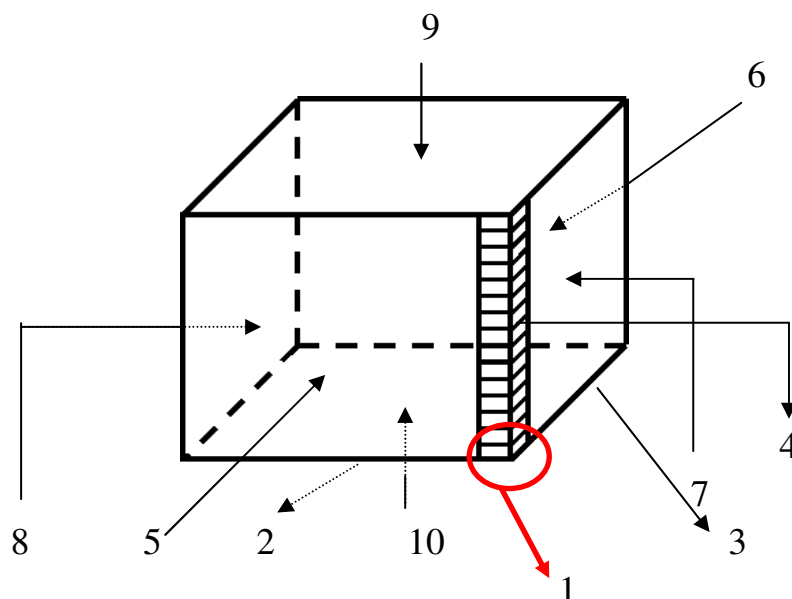
| 1 | The 5-7-10 Corner | Corner |
| 2 | The longest edge radiating from that corner | Edge |
| 3 | The next longest edge radiating from that corner | Edge |
| 4 | The shortest edge radiating from that corner | Edge |
| 5 | Flat on one of the medium faces | Flat |
| 6 | Flat on one of the opposite medium faces | Flat |
| 7 | Flat on one of the smallest faces | Flat |
| 8 | Flat on one of the opposite small faces | Flat |
| 9 | Flat on one of the largest faces | Flat |
| 10 | Flat on one of the opposite largest faces | Flat |

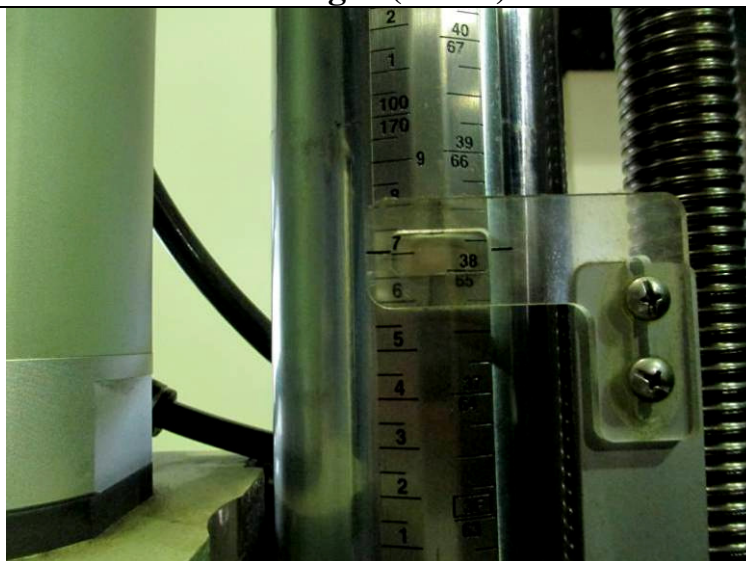
#### Height (97 cm)

Drop Height : 97 cm

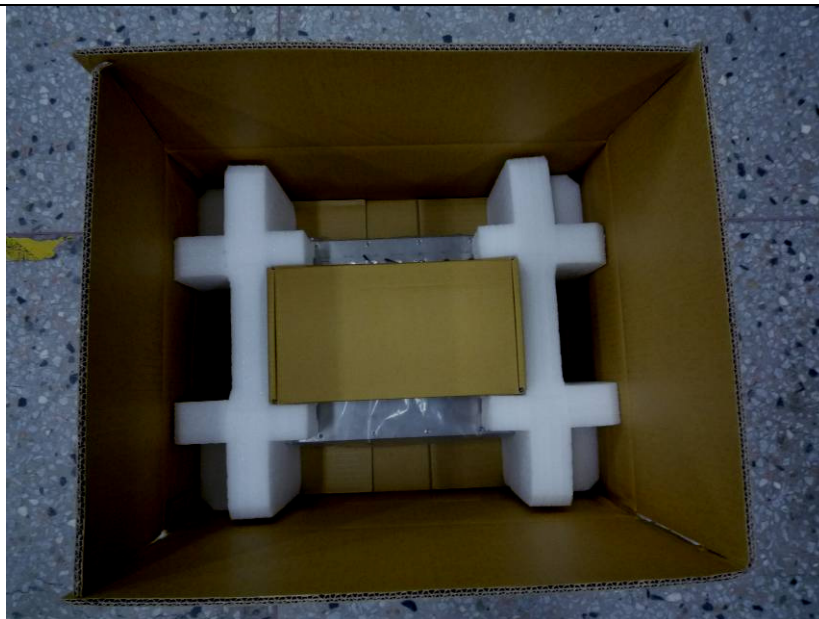
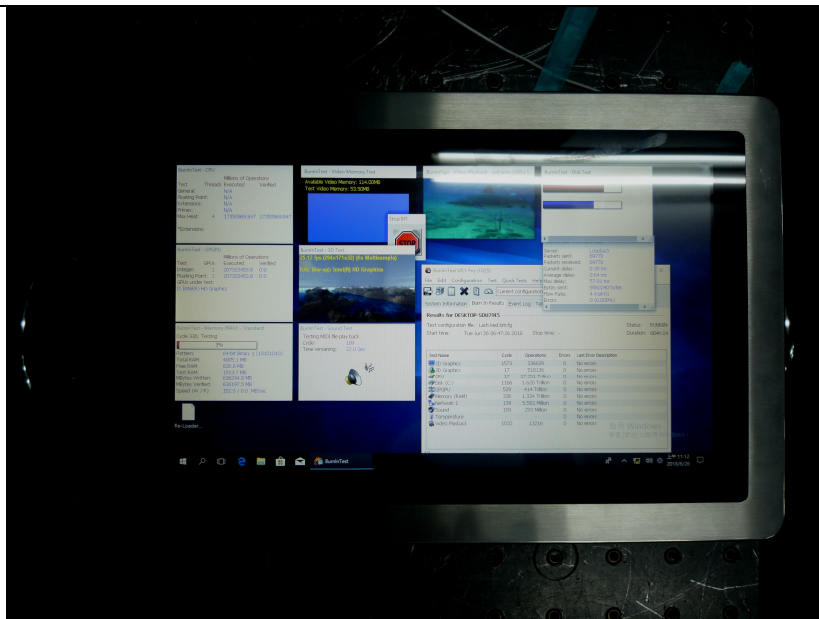
| Describe | PASS | FAIL | Non-Judgment |
|---|---|---|---|
| (1)—Bootting function was normal after the test. | | | |
| (2)—No visible damages were found. | | | |
