VIBRATION LABORATORY<http://www.kdi.tw><http://www.vibration.com.tw>E-mail: service@kdi.tw**TESTING / INSPECTION REPORT**

REPORT NO : VT-180712-1R

SPECIMEN : TWP1560-BSW series

TEST / INSPECTION ITEMS : Vibration Test

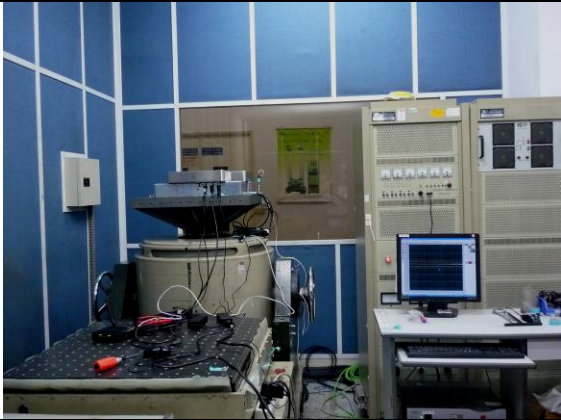
Vibration testing photos	
Testing equipment	Z axis
