VIBRATION LABORATORY<http://www.kdi.tw><http://www.vibration.com.tw>E-mail: service@kdi.tw**TESTING / INSPECTION REPORT**

REPORT NO : VT-171212-2

SPECIMEN : TEP0700-IMX7 series

TEST / INSPECTION ITEMS : Vibration Test

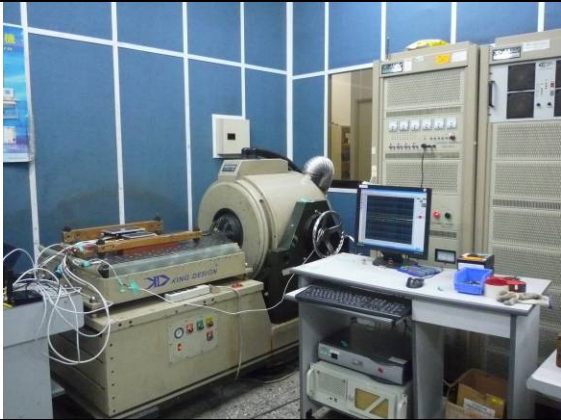
Vibration testing photos	
Testing equipment	Z axis

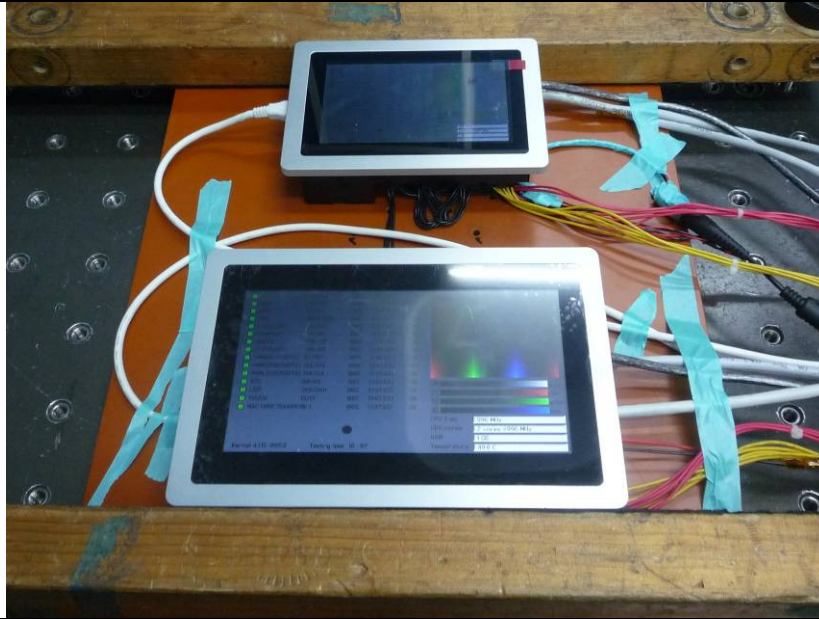
Testing photos
After test-1

Describe	PASS	FAIL	Non-Judgment
Function judgment	√	---	---
Appearance check	√	---	---
