**TESTING / INSPECTION REPORT**

REPORT NO : DT-171212-2

COMPANY : TechNexion Ltd.  
ADDRESS : 16F-5, No. 736, Zhongzheng Road, ZhongHe District, 23511,  
New Taipei City, Taiwan  
TEL : 886-2-8227-3585  
FAX : 886-2-8227-3590  
SPECIMEN : TEP0700-IMX7 series  
TEP1-i.MX7 DUAL --- TEP1-IMX7D  
Power Expansion-LPOE --- TXR-P1-12V-POE1

TEST / INSPECTION ITEMS : Drop Test

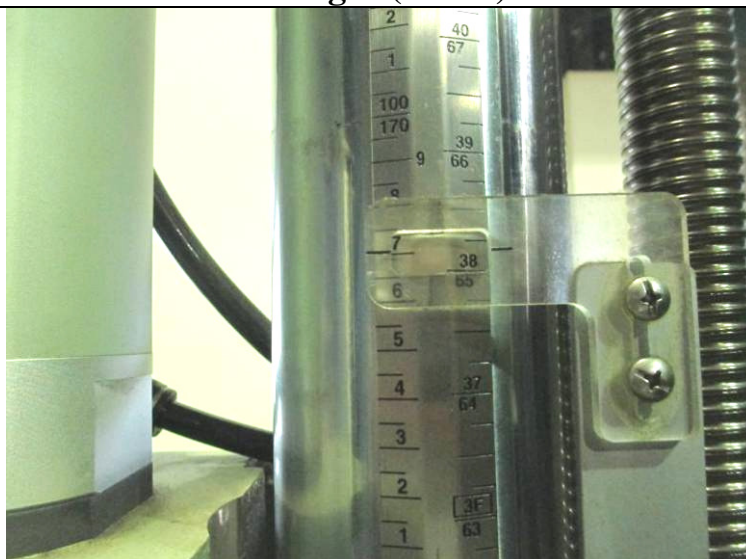
#### Height (97 cm)

Drop Height : 97 cm

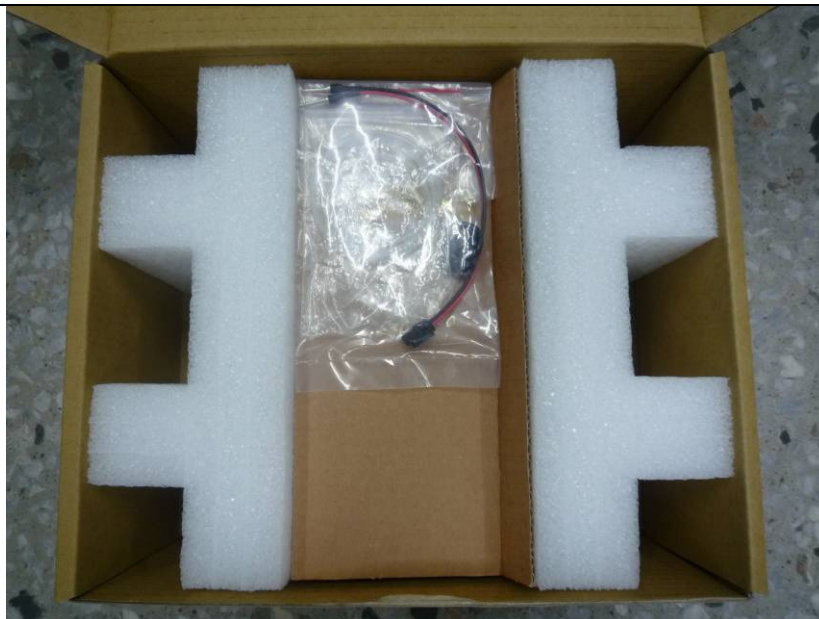
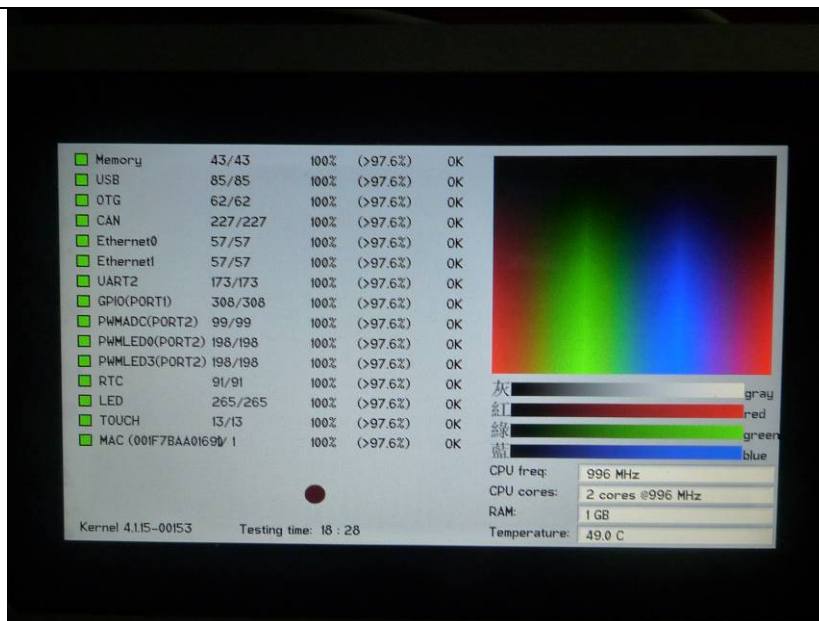
| Describe | PASS | FAIL | Non-Judgment |
|---|---|---|---|
| (1)—Bootting function was normal after the test. | | | |
| (2)—No visible damages were found. | | | |
