**TESTING / INSPECTION REPORT**

REPORT NO : DT-180712-2R

TEST / INSPECTION ITEMS : Drop Test

Model : TWP1010-BSW series  
TN140\_TEP5-BSW --- TEP5-BSW-N3710  
Power Expansion L124 --- TXB-P1-24V-LAN1  
I/O Expansion XG21--- TXB-I2-GS2-GG8

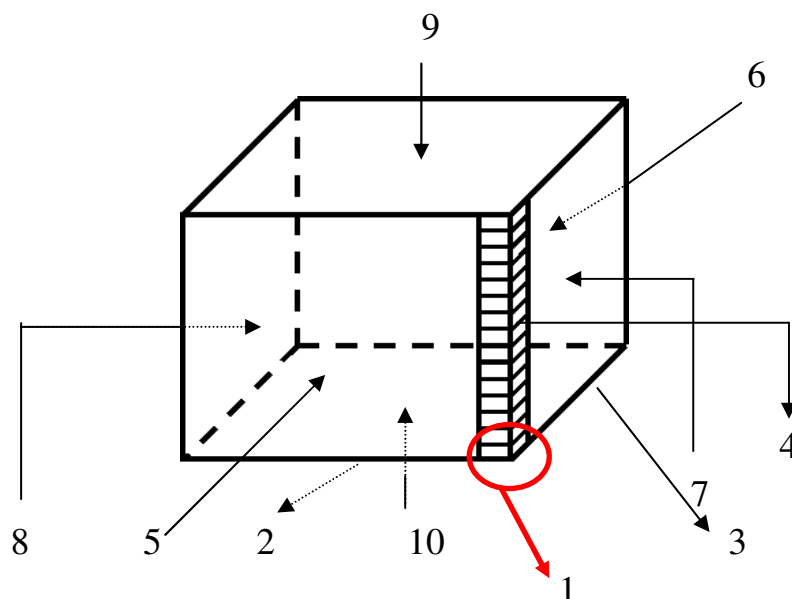
| 1 | The 5-7-10 Corner | Corner |
| 2 | The longest edge radiating from that corner | Edge |
| 3 | The next longest edge radiating from that corner | Edge |
| 4 | The shortest edge radiating from that corner | Edge |
| 5 | Flat on one of the medium faces | Flat |
| 6 | Flat on one of the opposite medium faces | Flat |
| 7 | Flat on one of the smallest faces | Flat |
| 8 | Flat on one of the opposite small faces | Flat |
| 9 | Flat on one of the largest faces | Flat |
| 10 | Flat on one of the opposite largest faces | Flat |

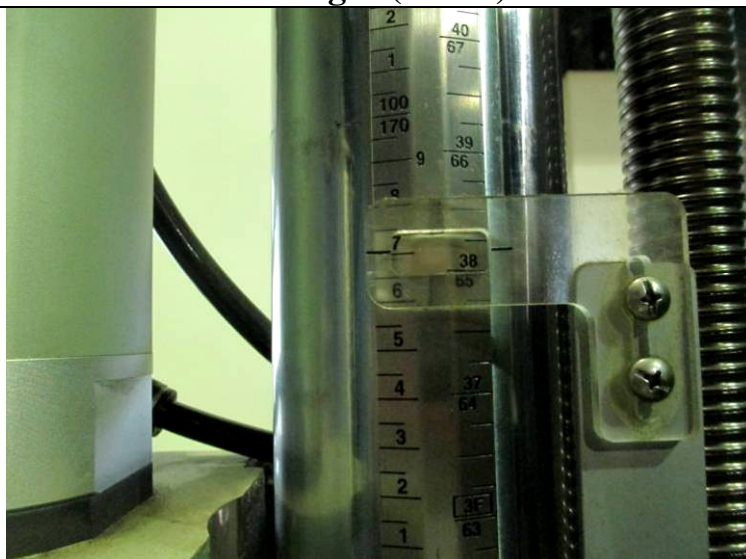
#### Height (97 cm)

Drop Height : 97 cm

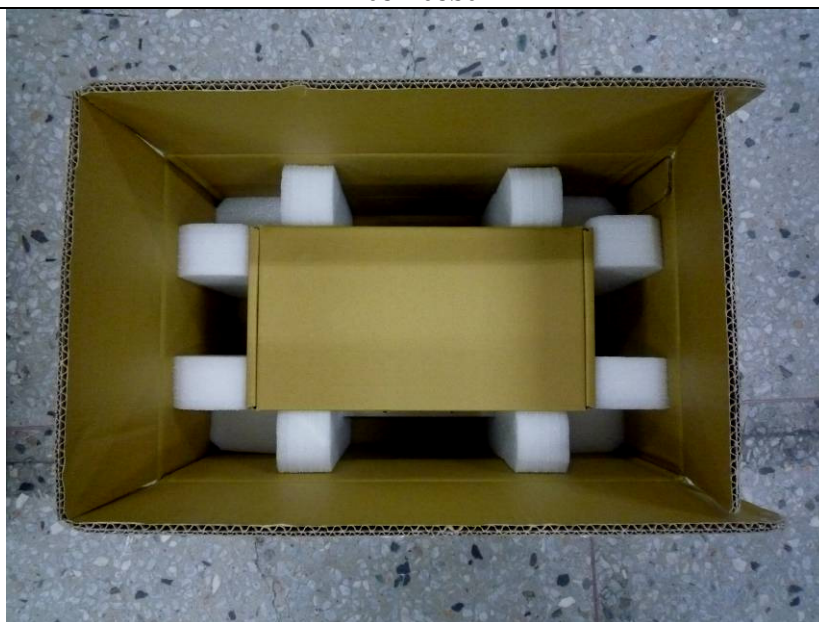
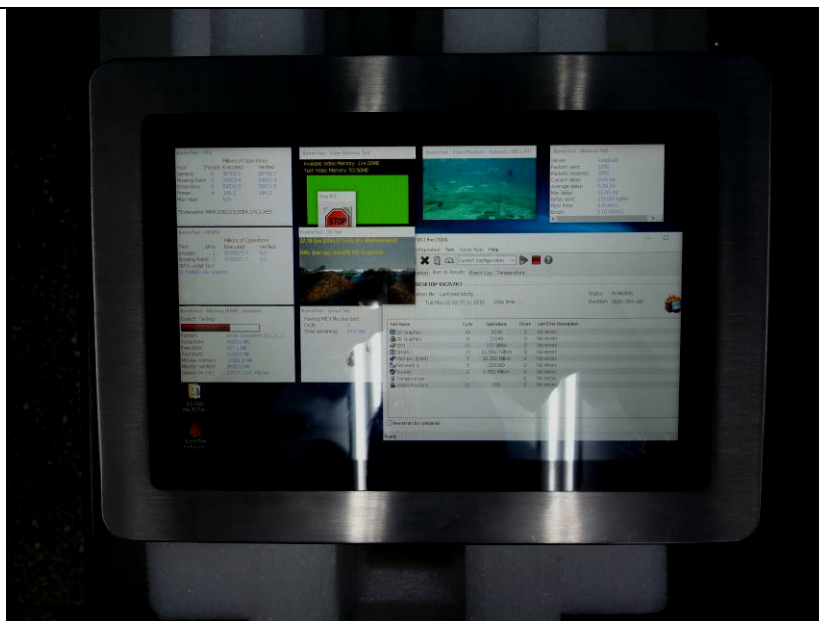
| Describe | PASS | FAIL | Non-Judgment |
|---|---|---|---|
| (2)—No visible damages were found. | | | |

#### After test-1

#### After test-2
